Effects of bank vegetation in waterways with special reference to bank erosion, shear strength, root density and channel hydraulics

**Effects of Bank Vegetation in Waterways with Special
Reference to Bank Erosion, Shear Strength, Root Density and
Channel Hydraulics**

**A thesis submitted to the Open University
for the Degree of Doctor of Philosophy
Biology Department
September 1992**

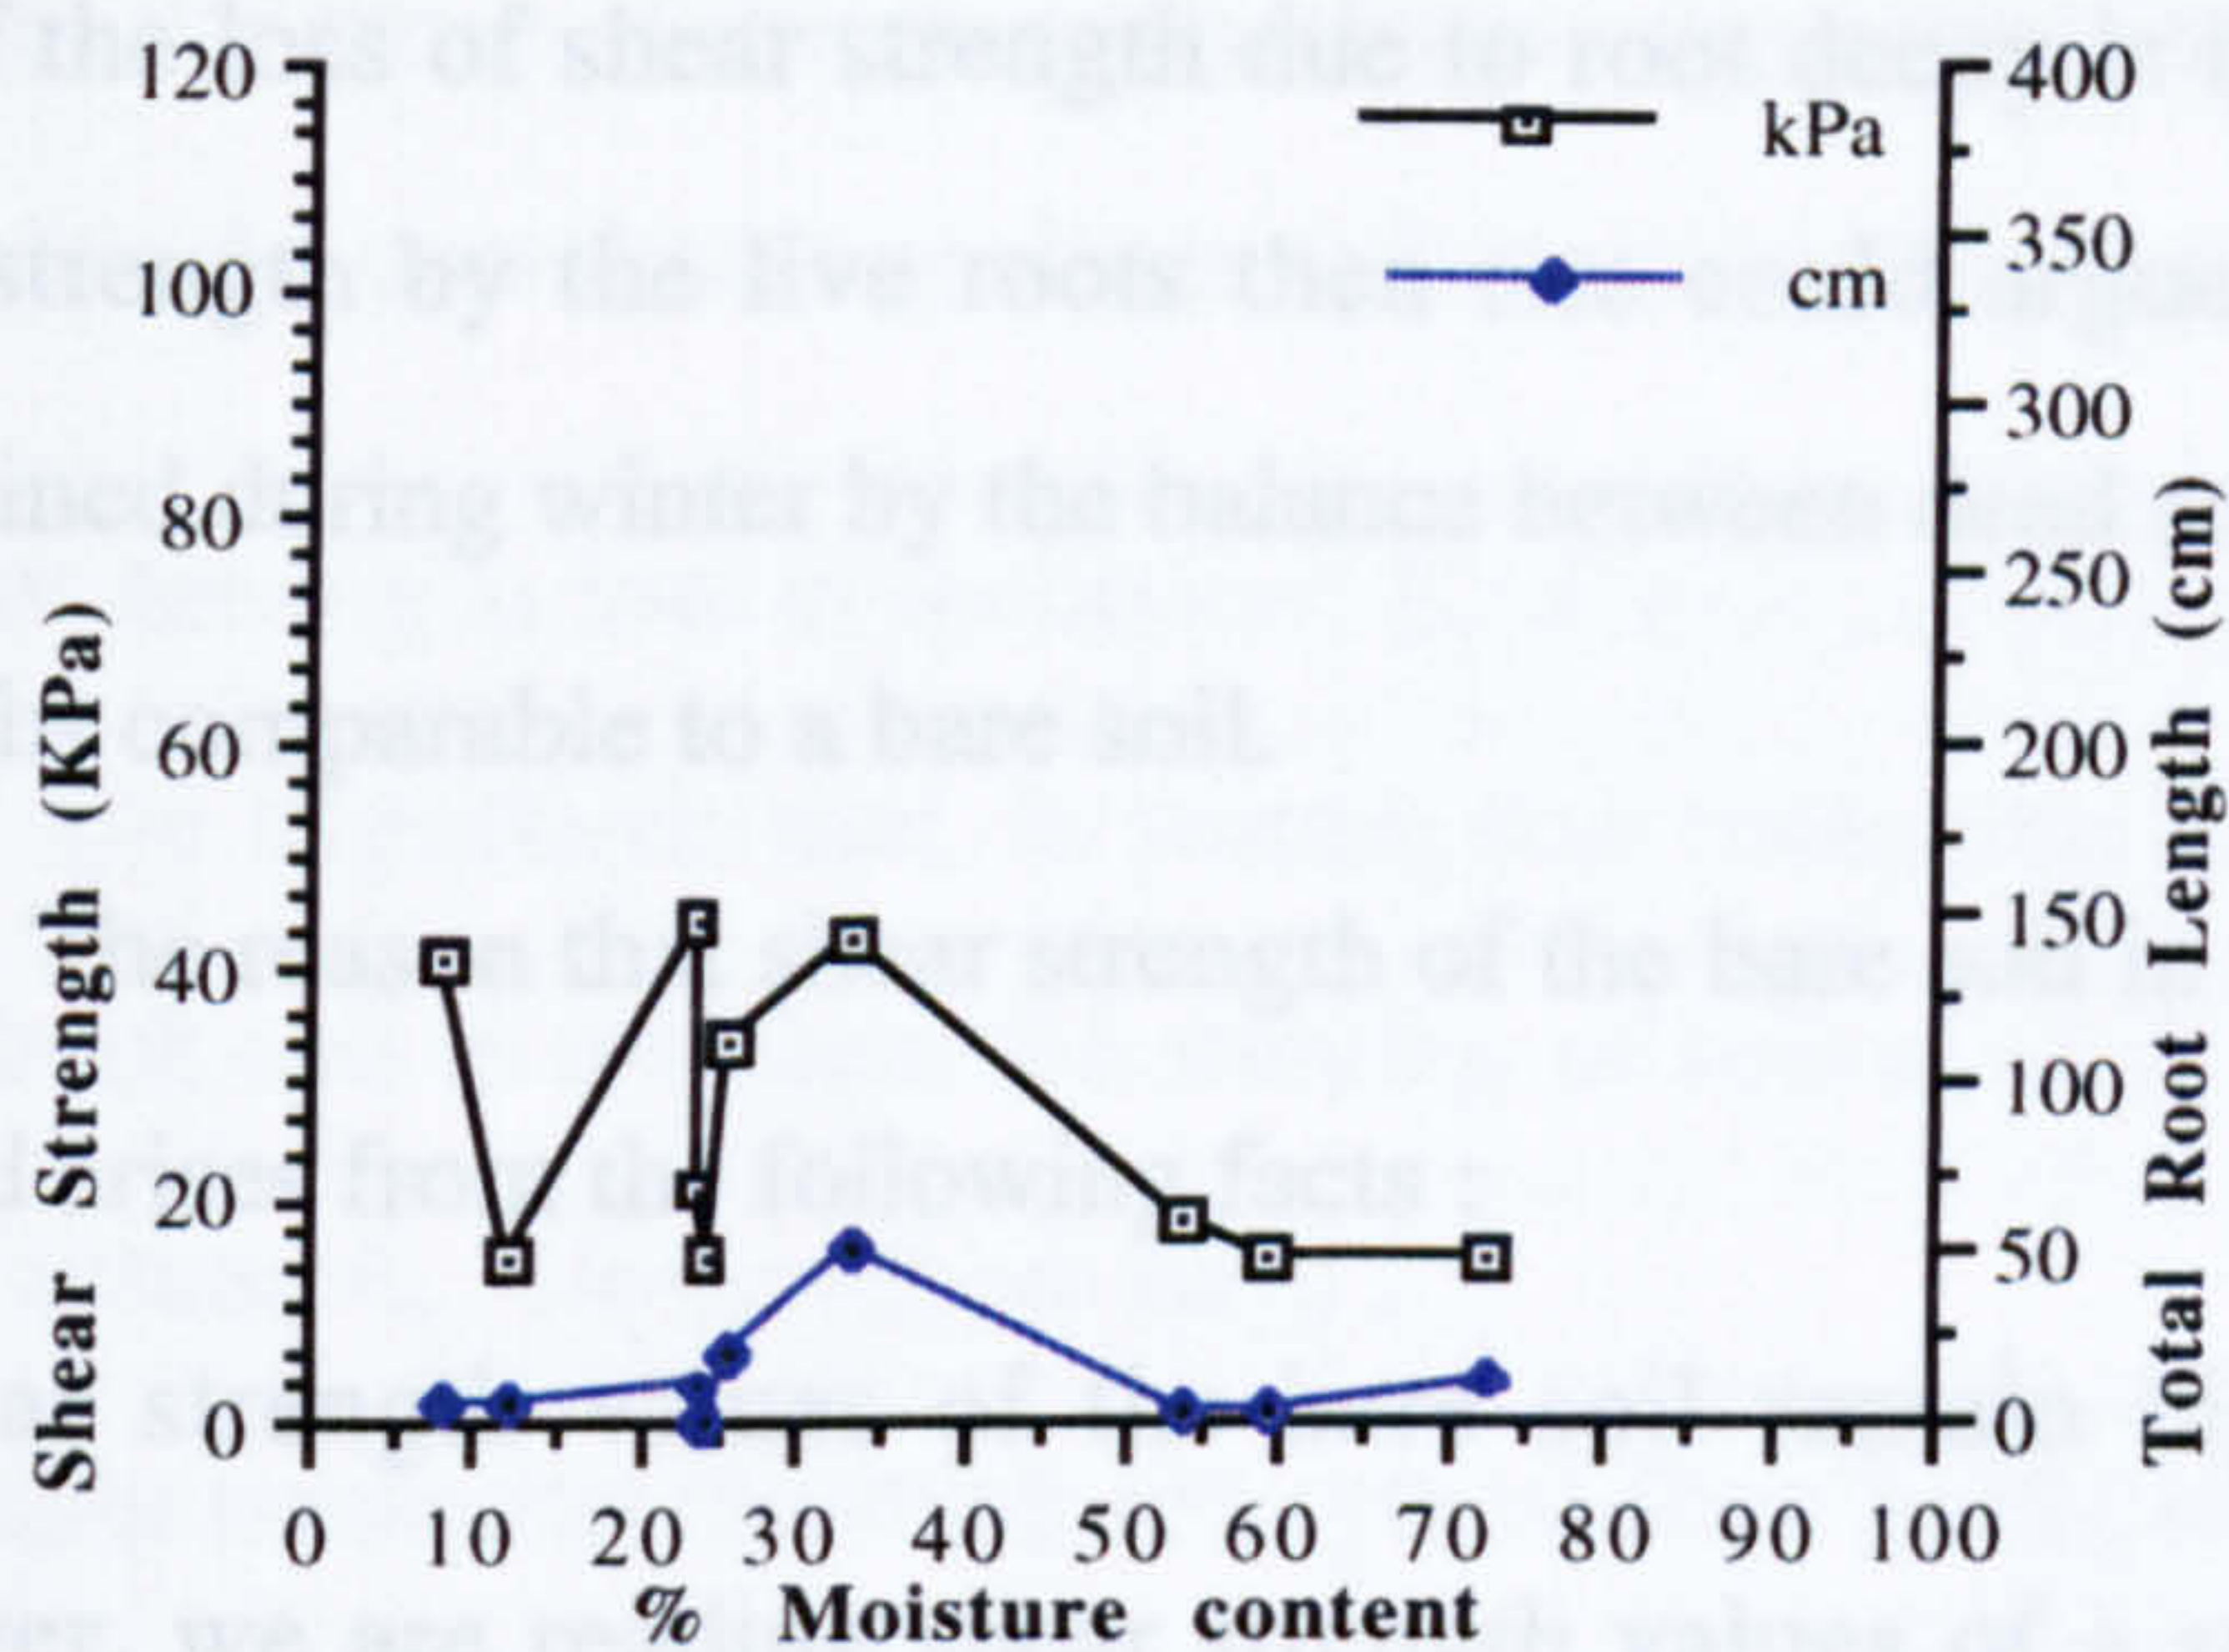
Fig.3.13a : Shear strength, Root length and Moisture content variations on the bar (February 1988) for Bare banks

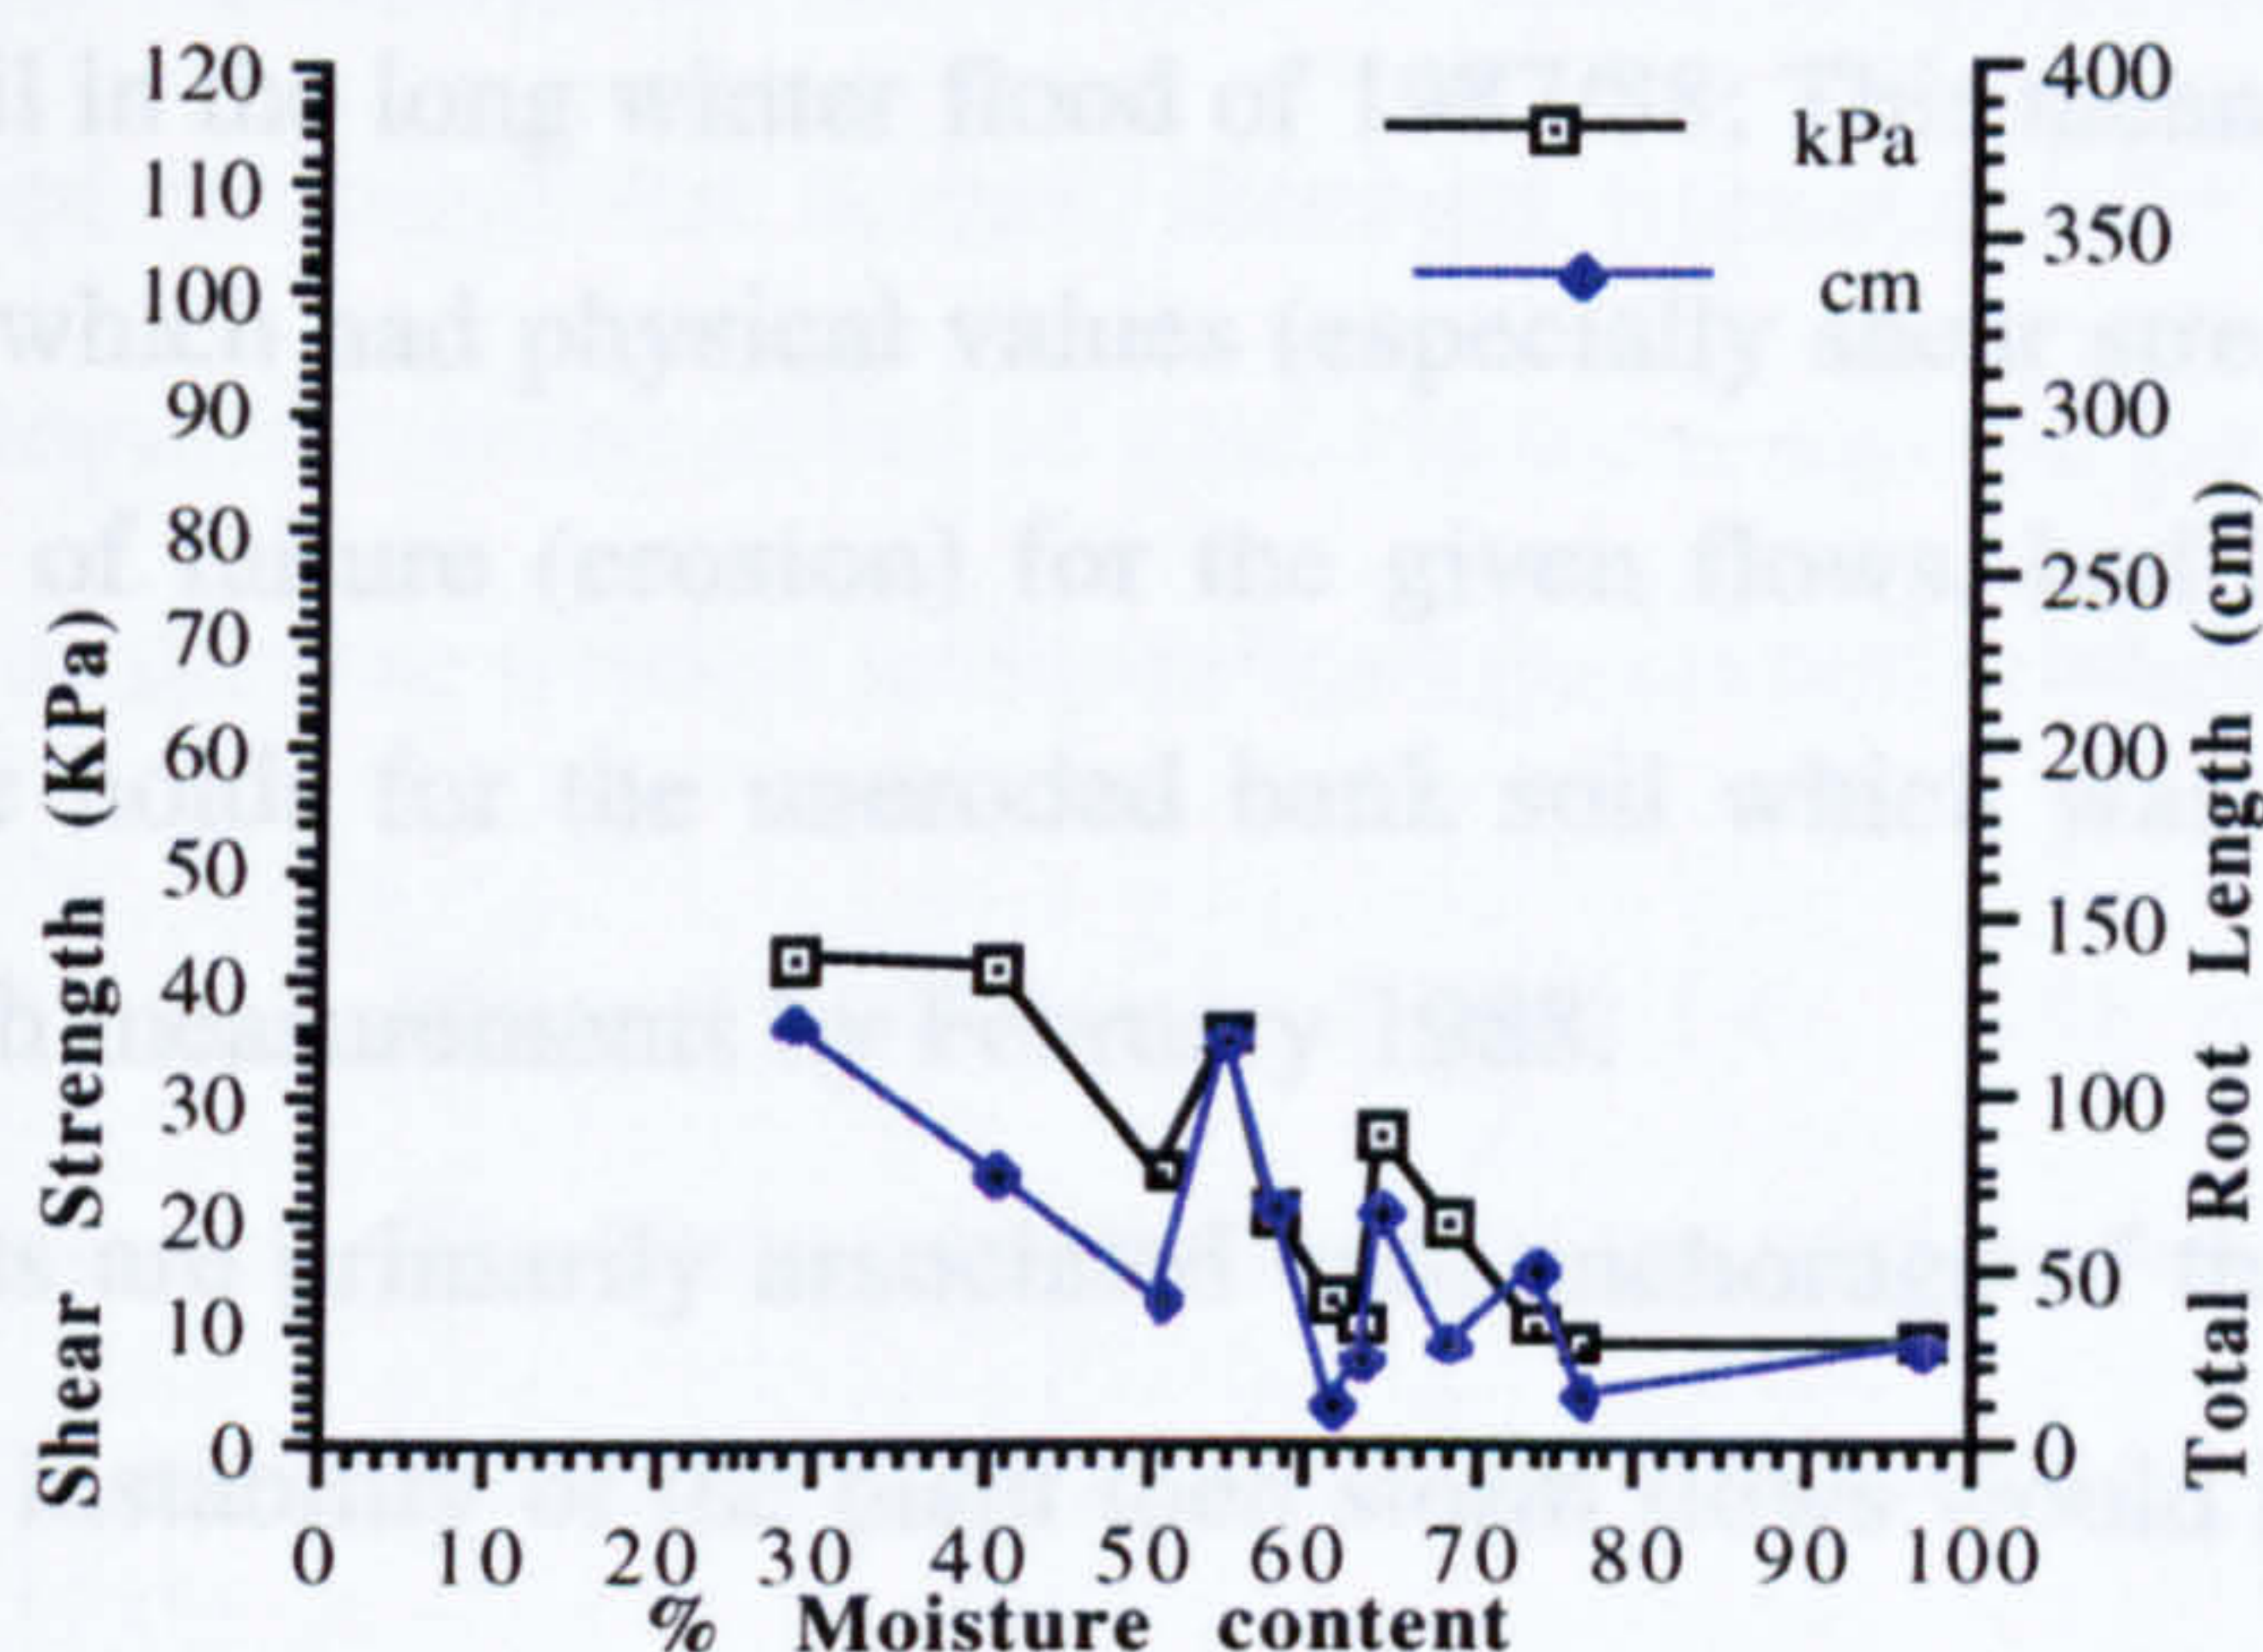
Fig.3.13b : Shear strength, Root length and moisture content variations (February 19) Natural vegetation dominated by *E. hirsutum* at levels 2 to 4;

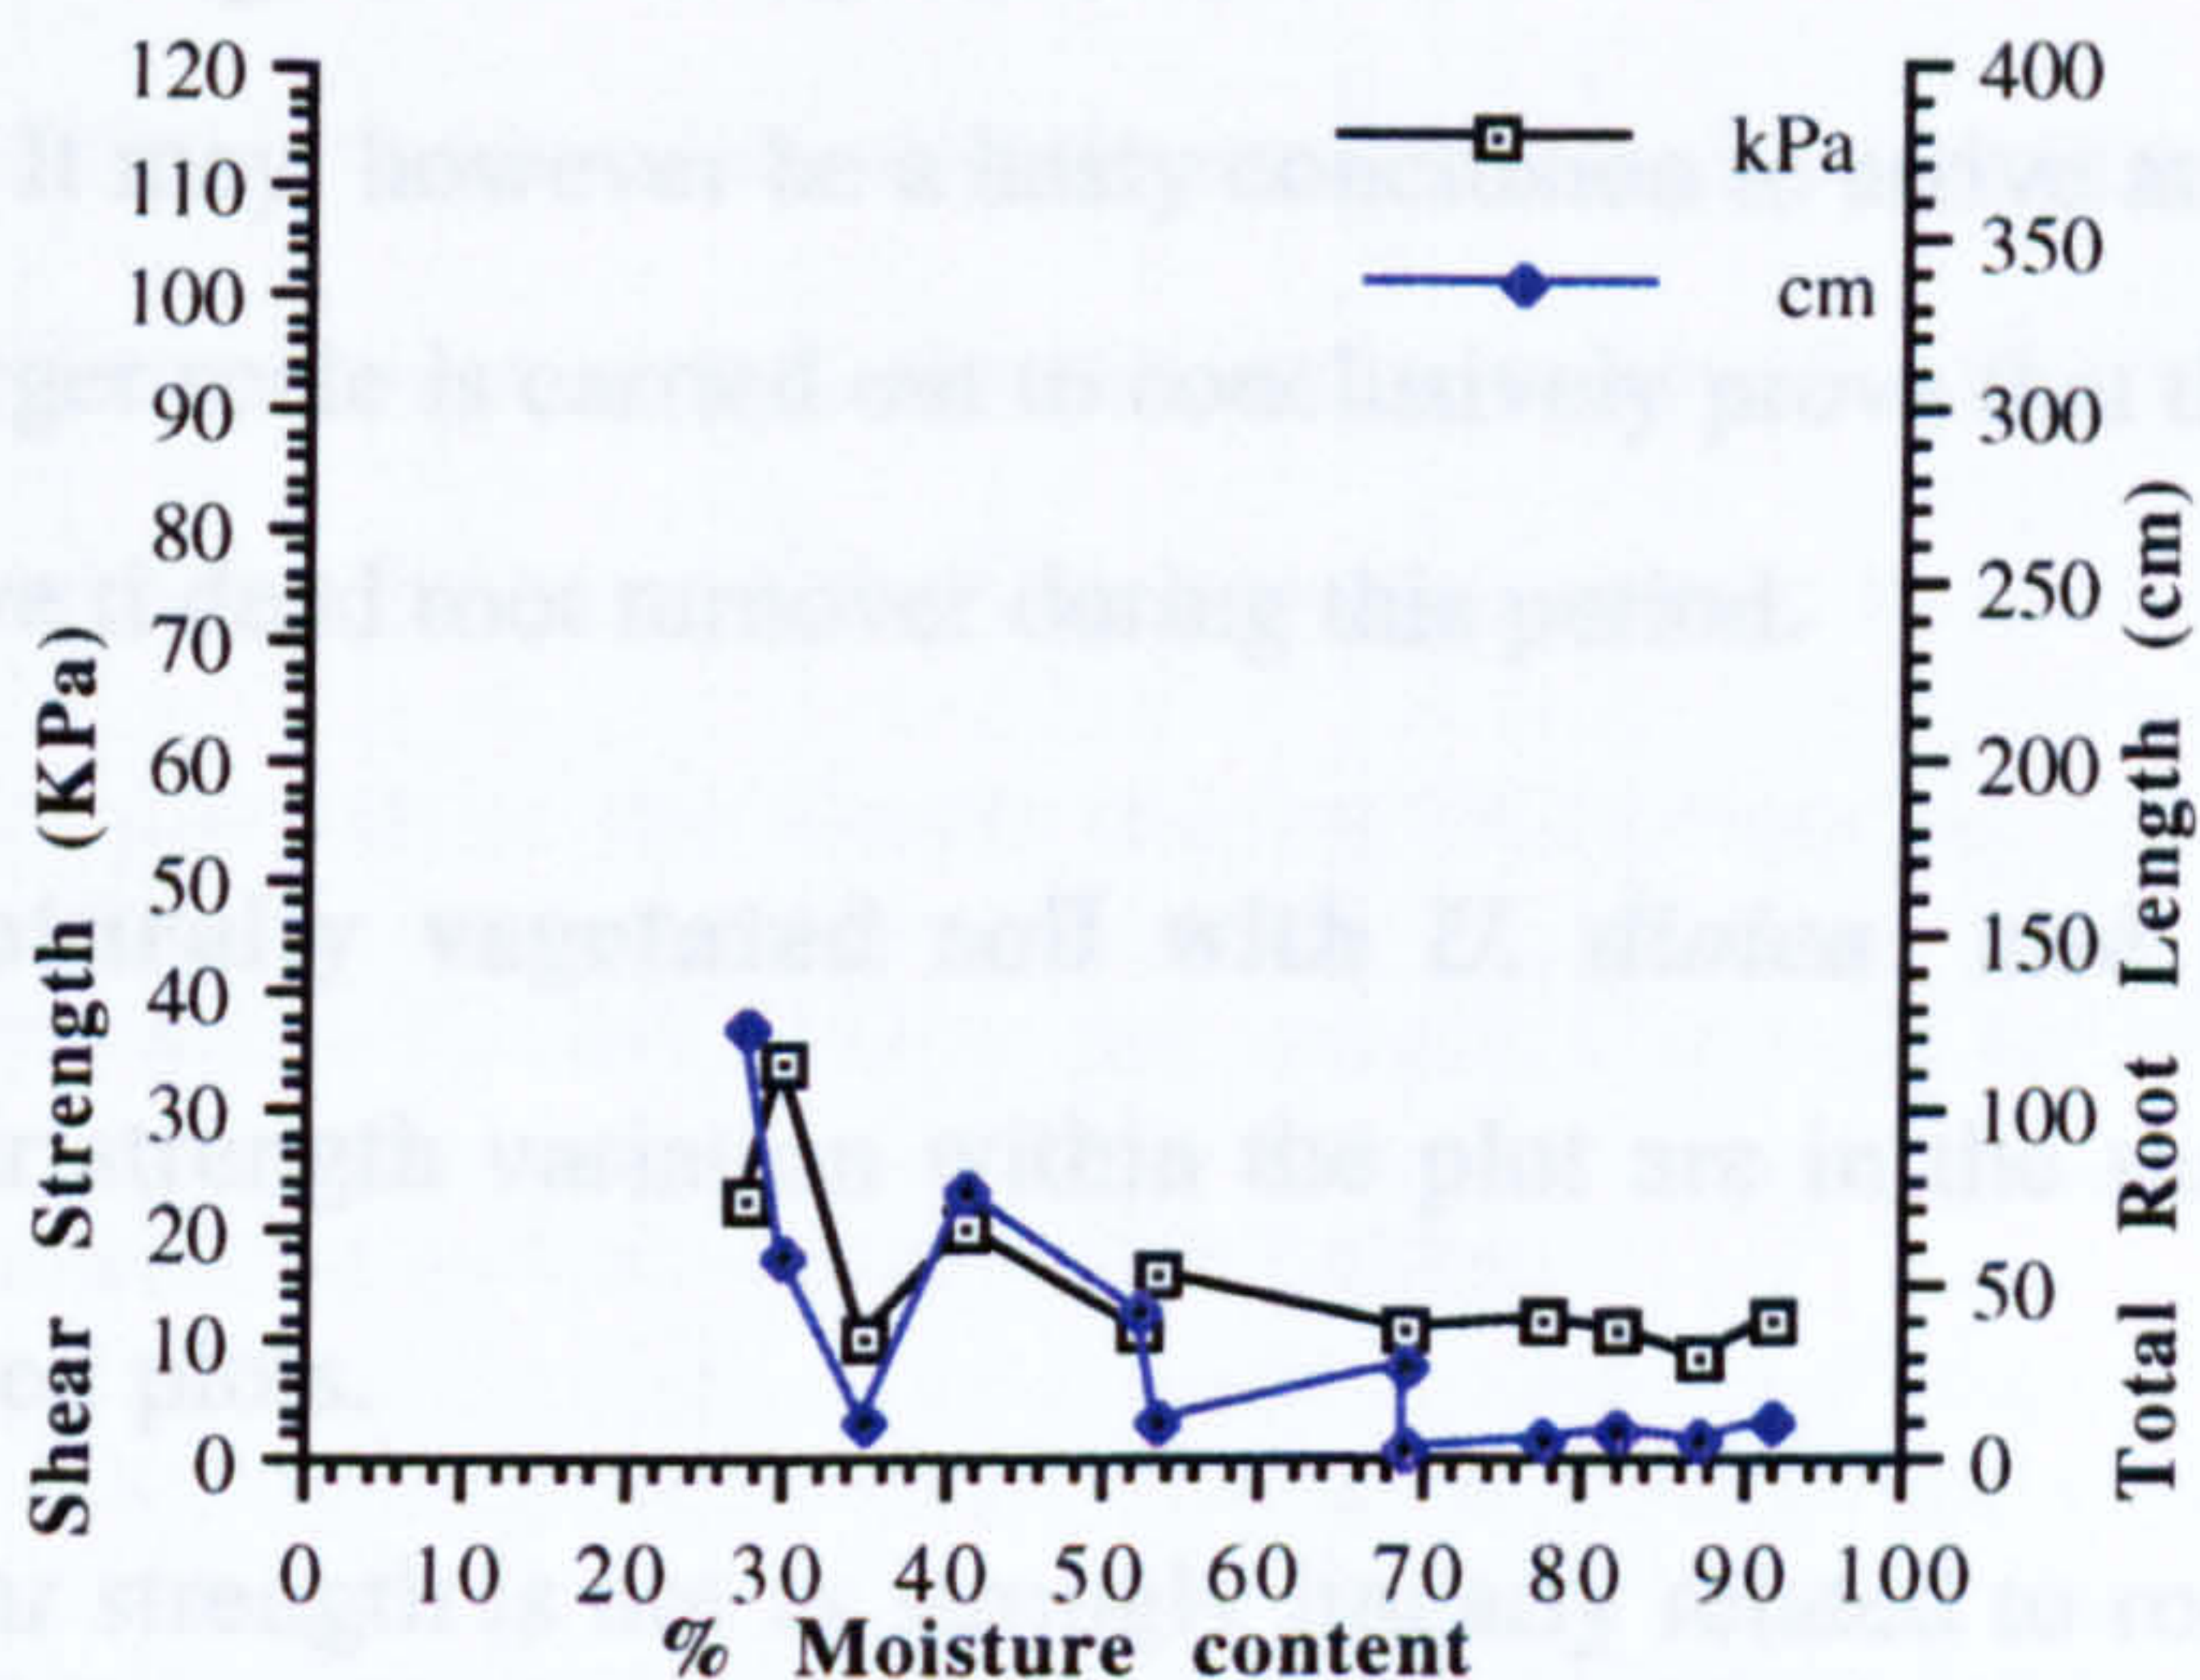
Fig. 3.13c : Shear strength, Root length and moisture content variations (February 19) Naturally vegetated banks dominated by *U.dioica* at levels 2 to 4;

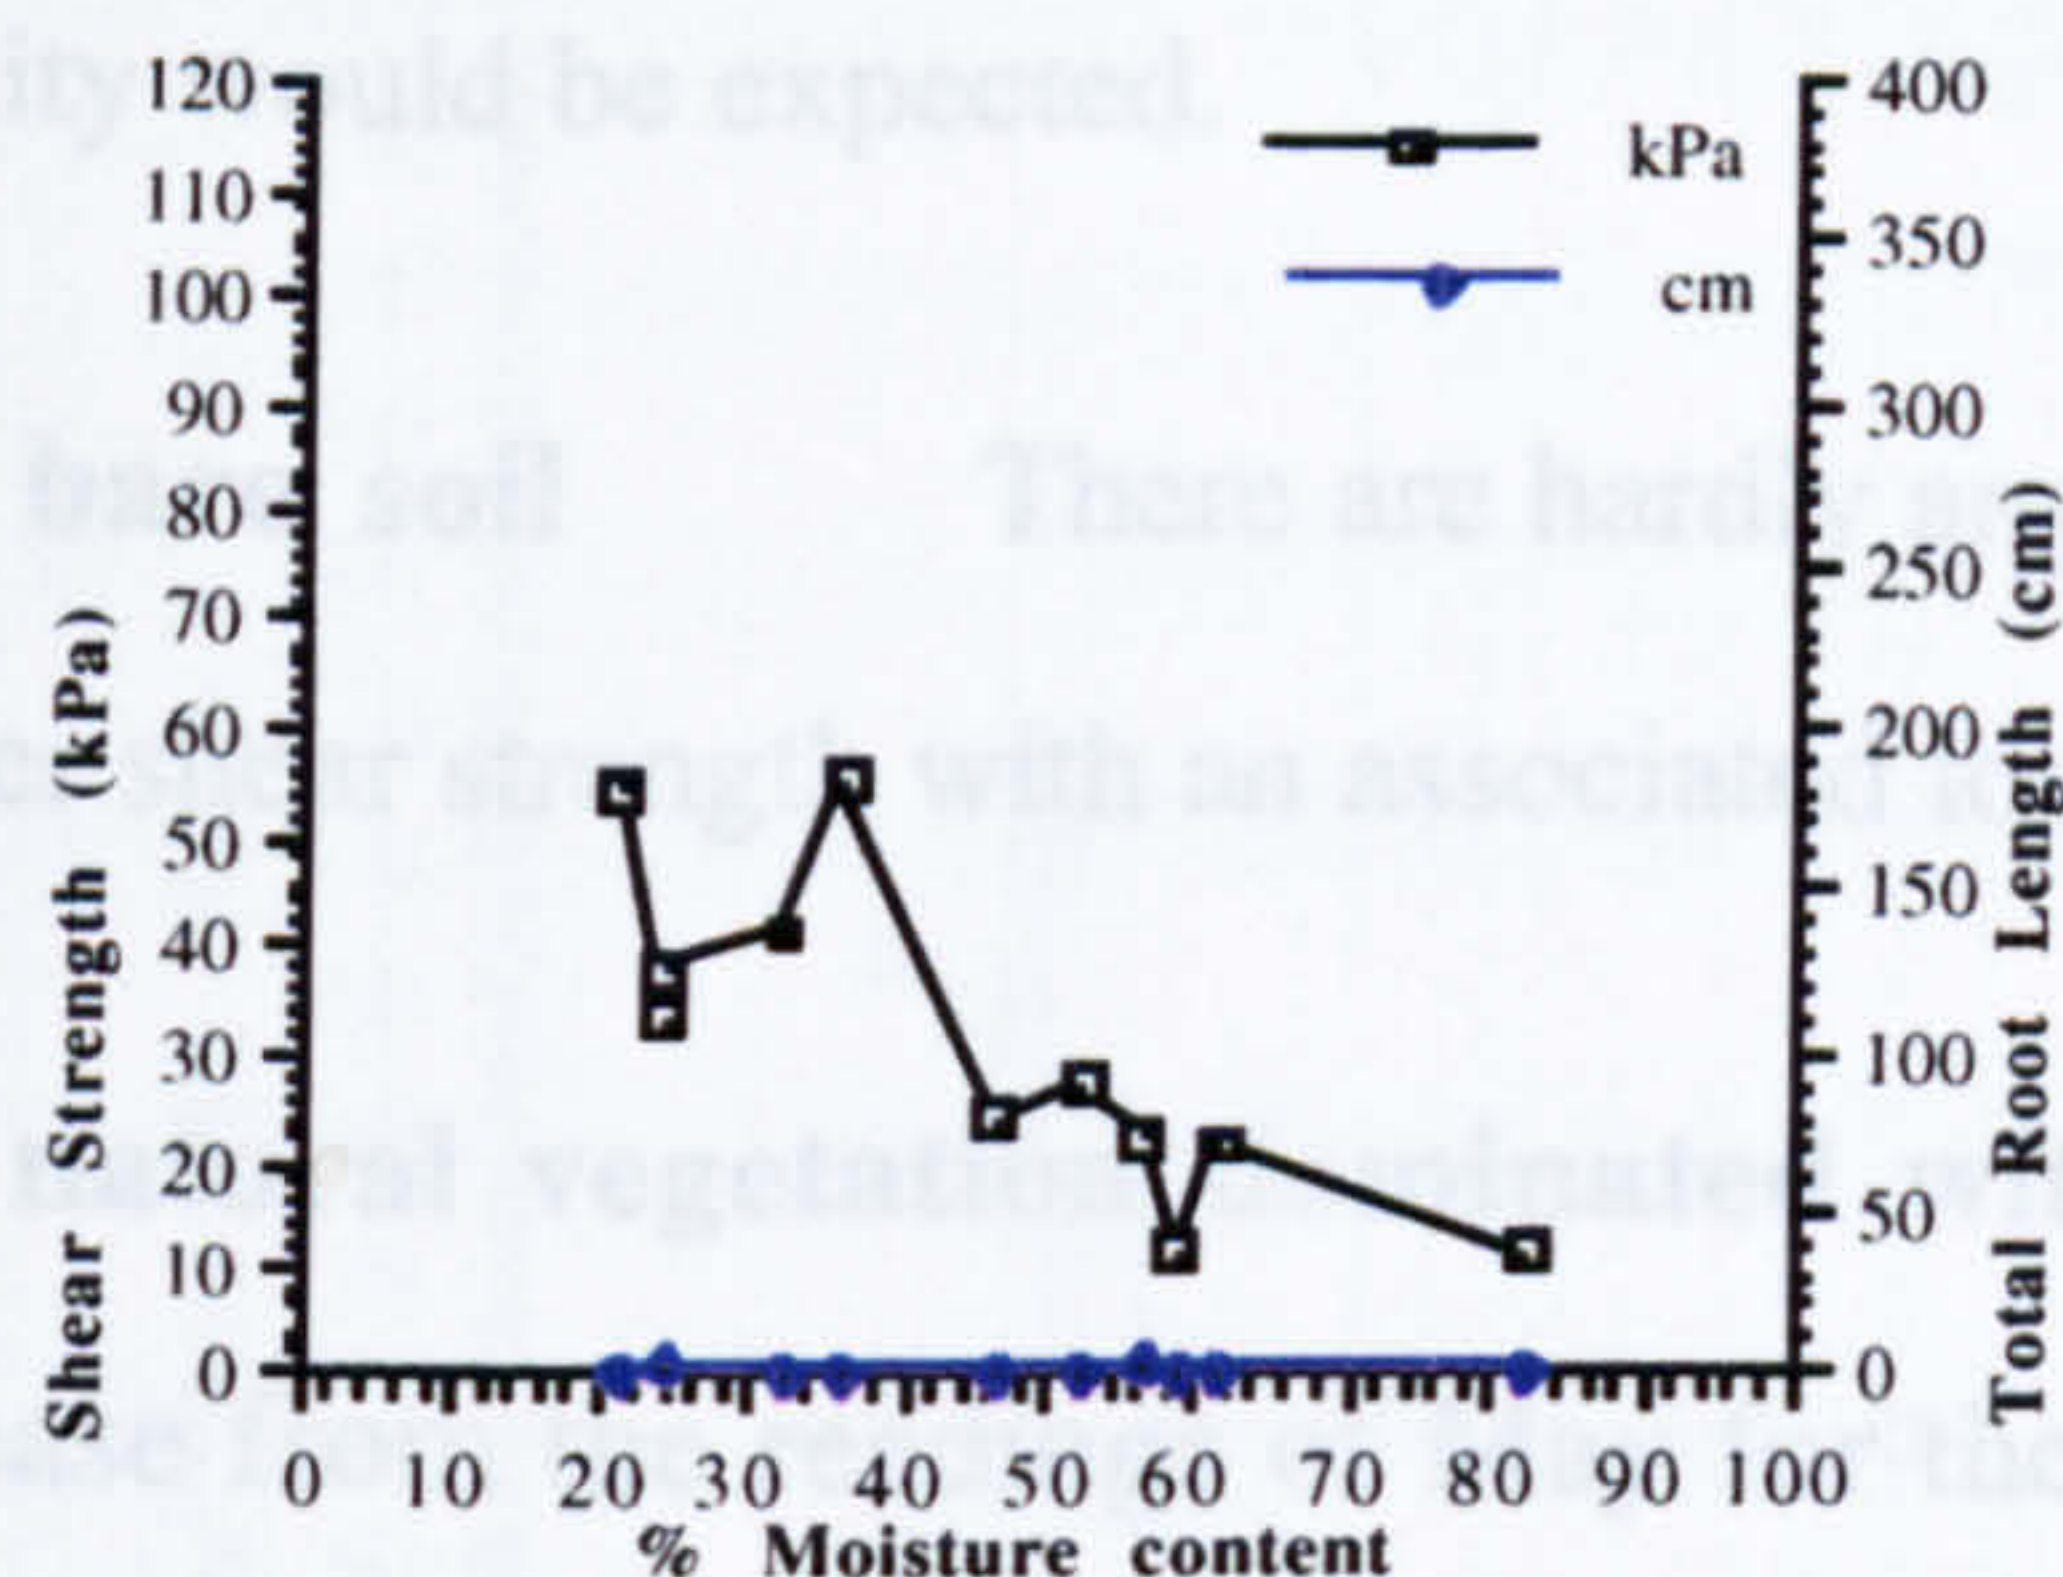
Fig. 3.14a : Shear strength, Root length and Moisture content variations (May 1981)
Bare banks;

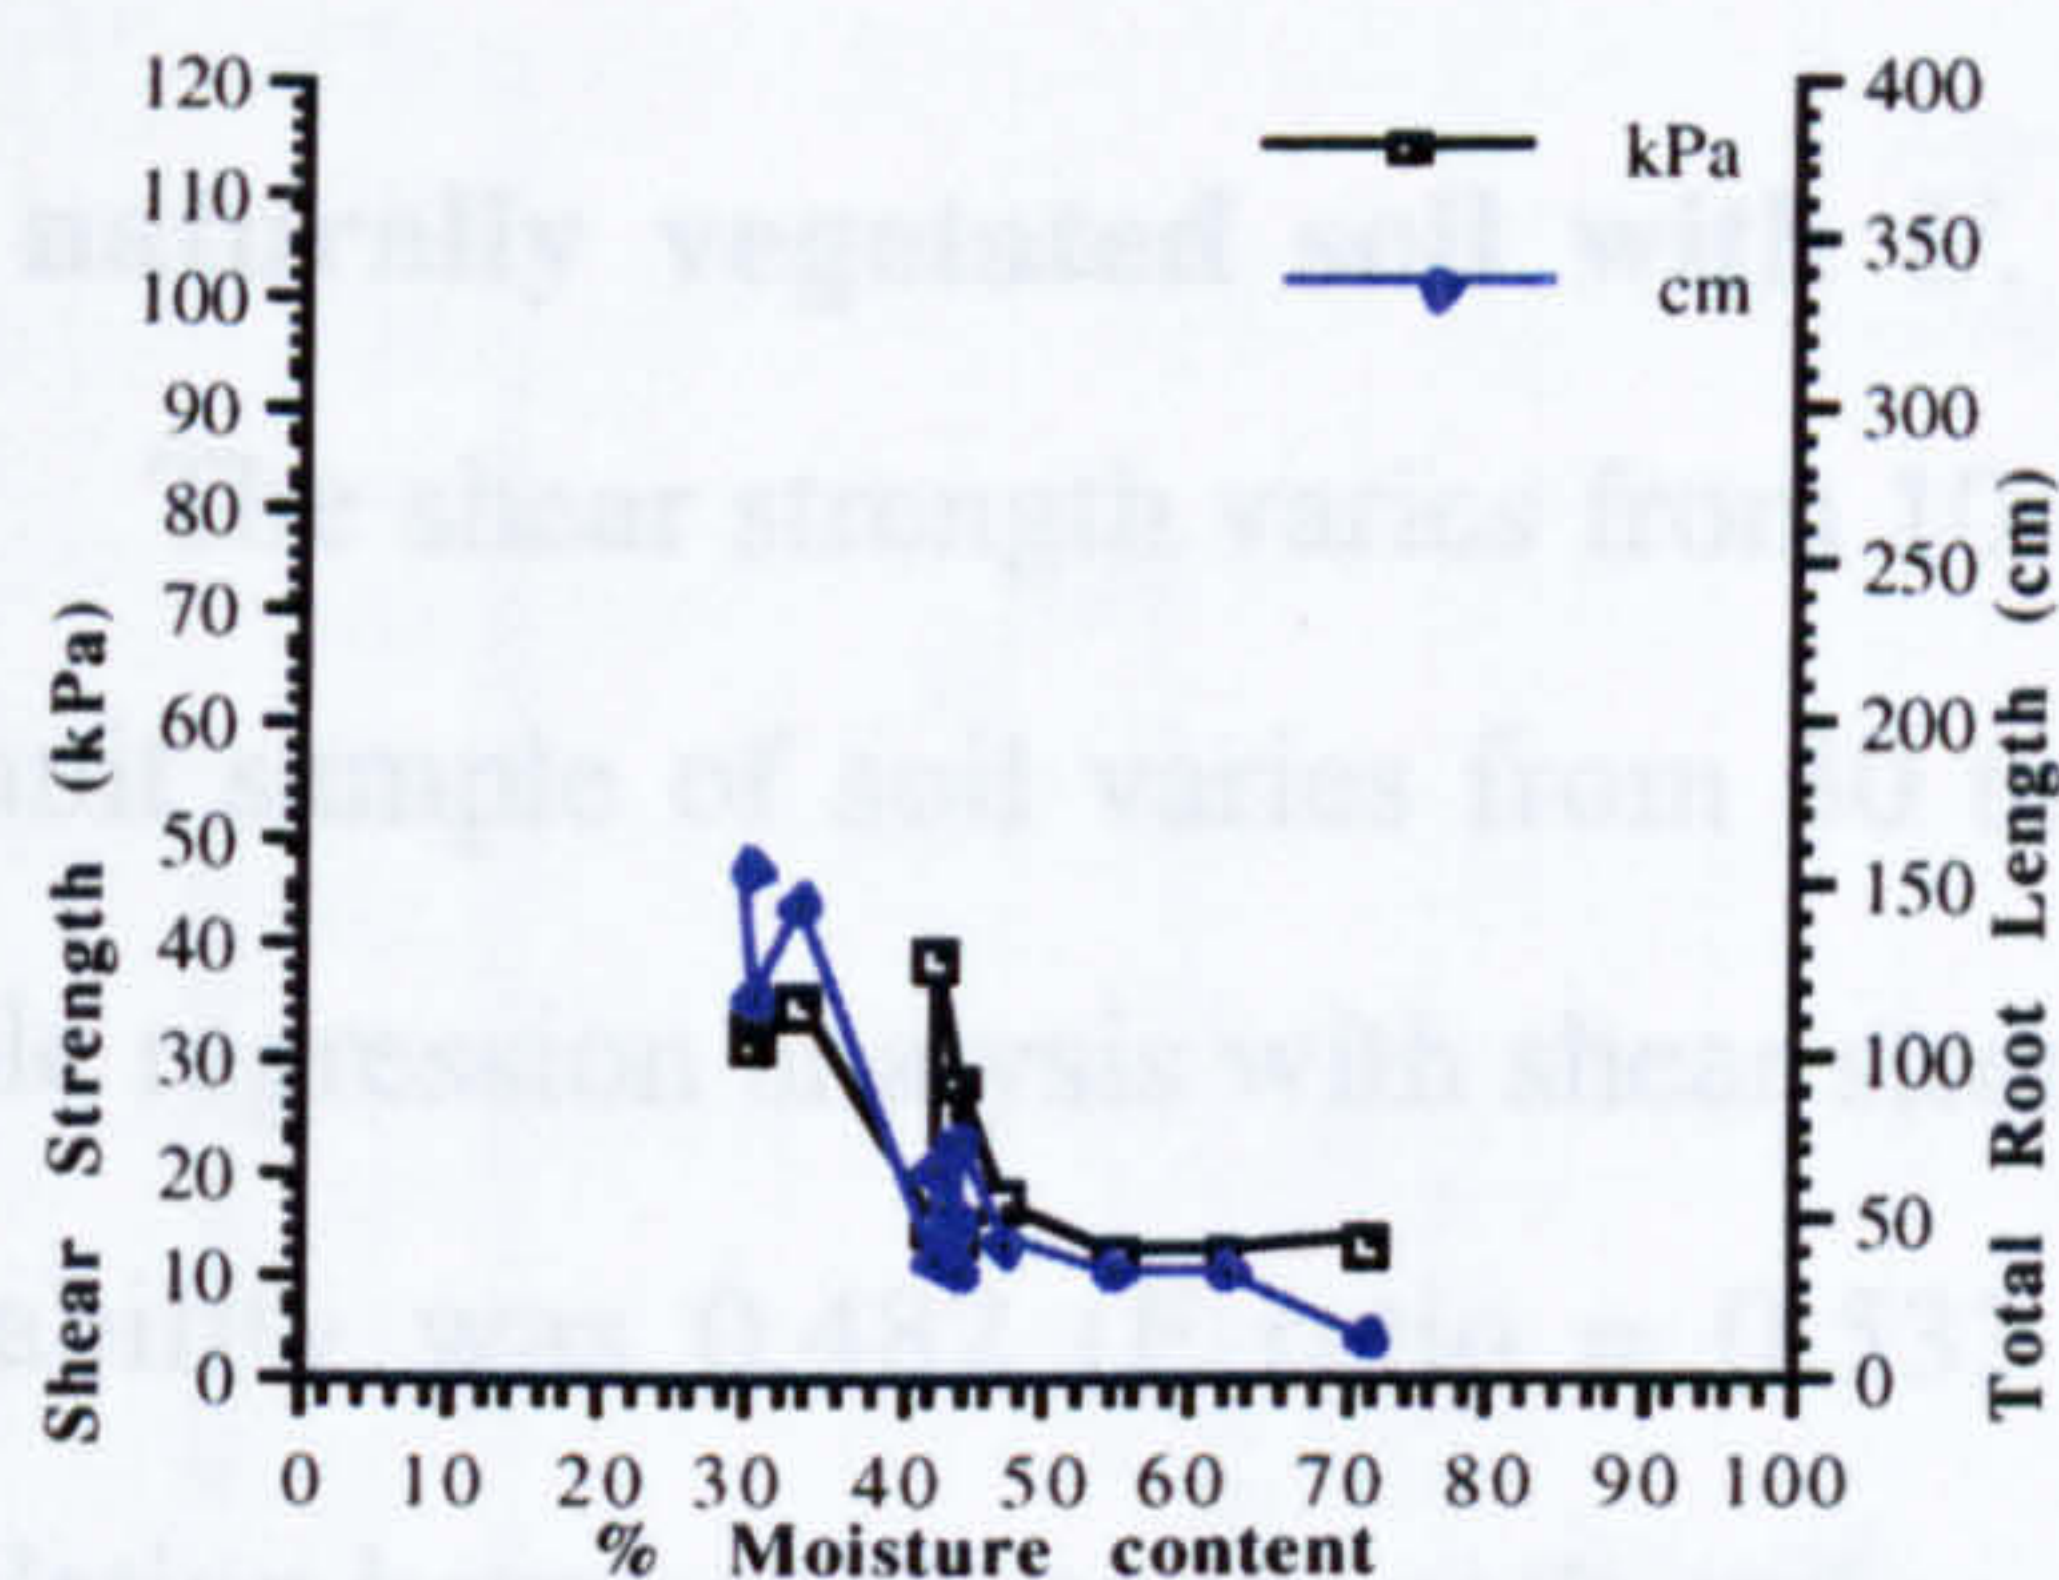
Fig. 3.14b : Shear strength, Root length and Moisture content variations (May 1981)
Naturally vegetated banks dominated by *E. hirsutum* at levels 2 to 4;

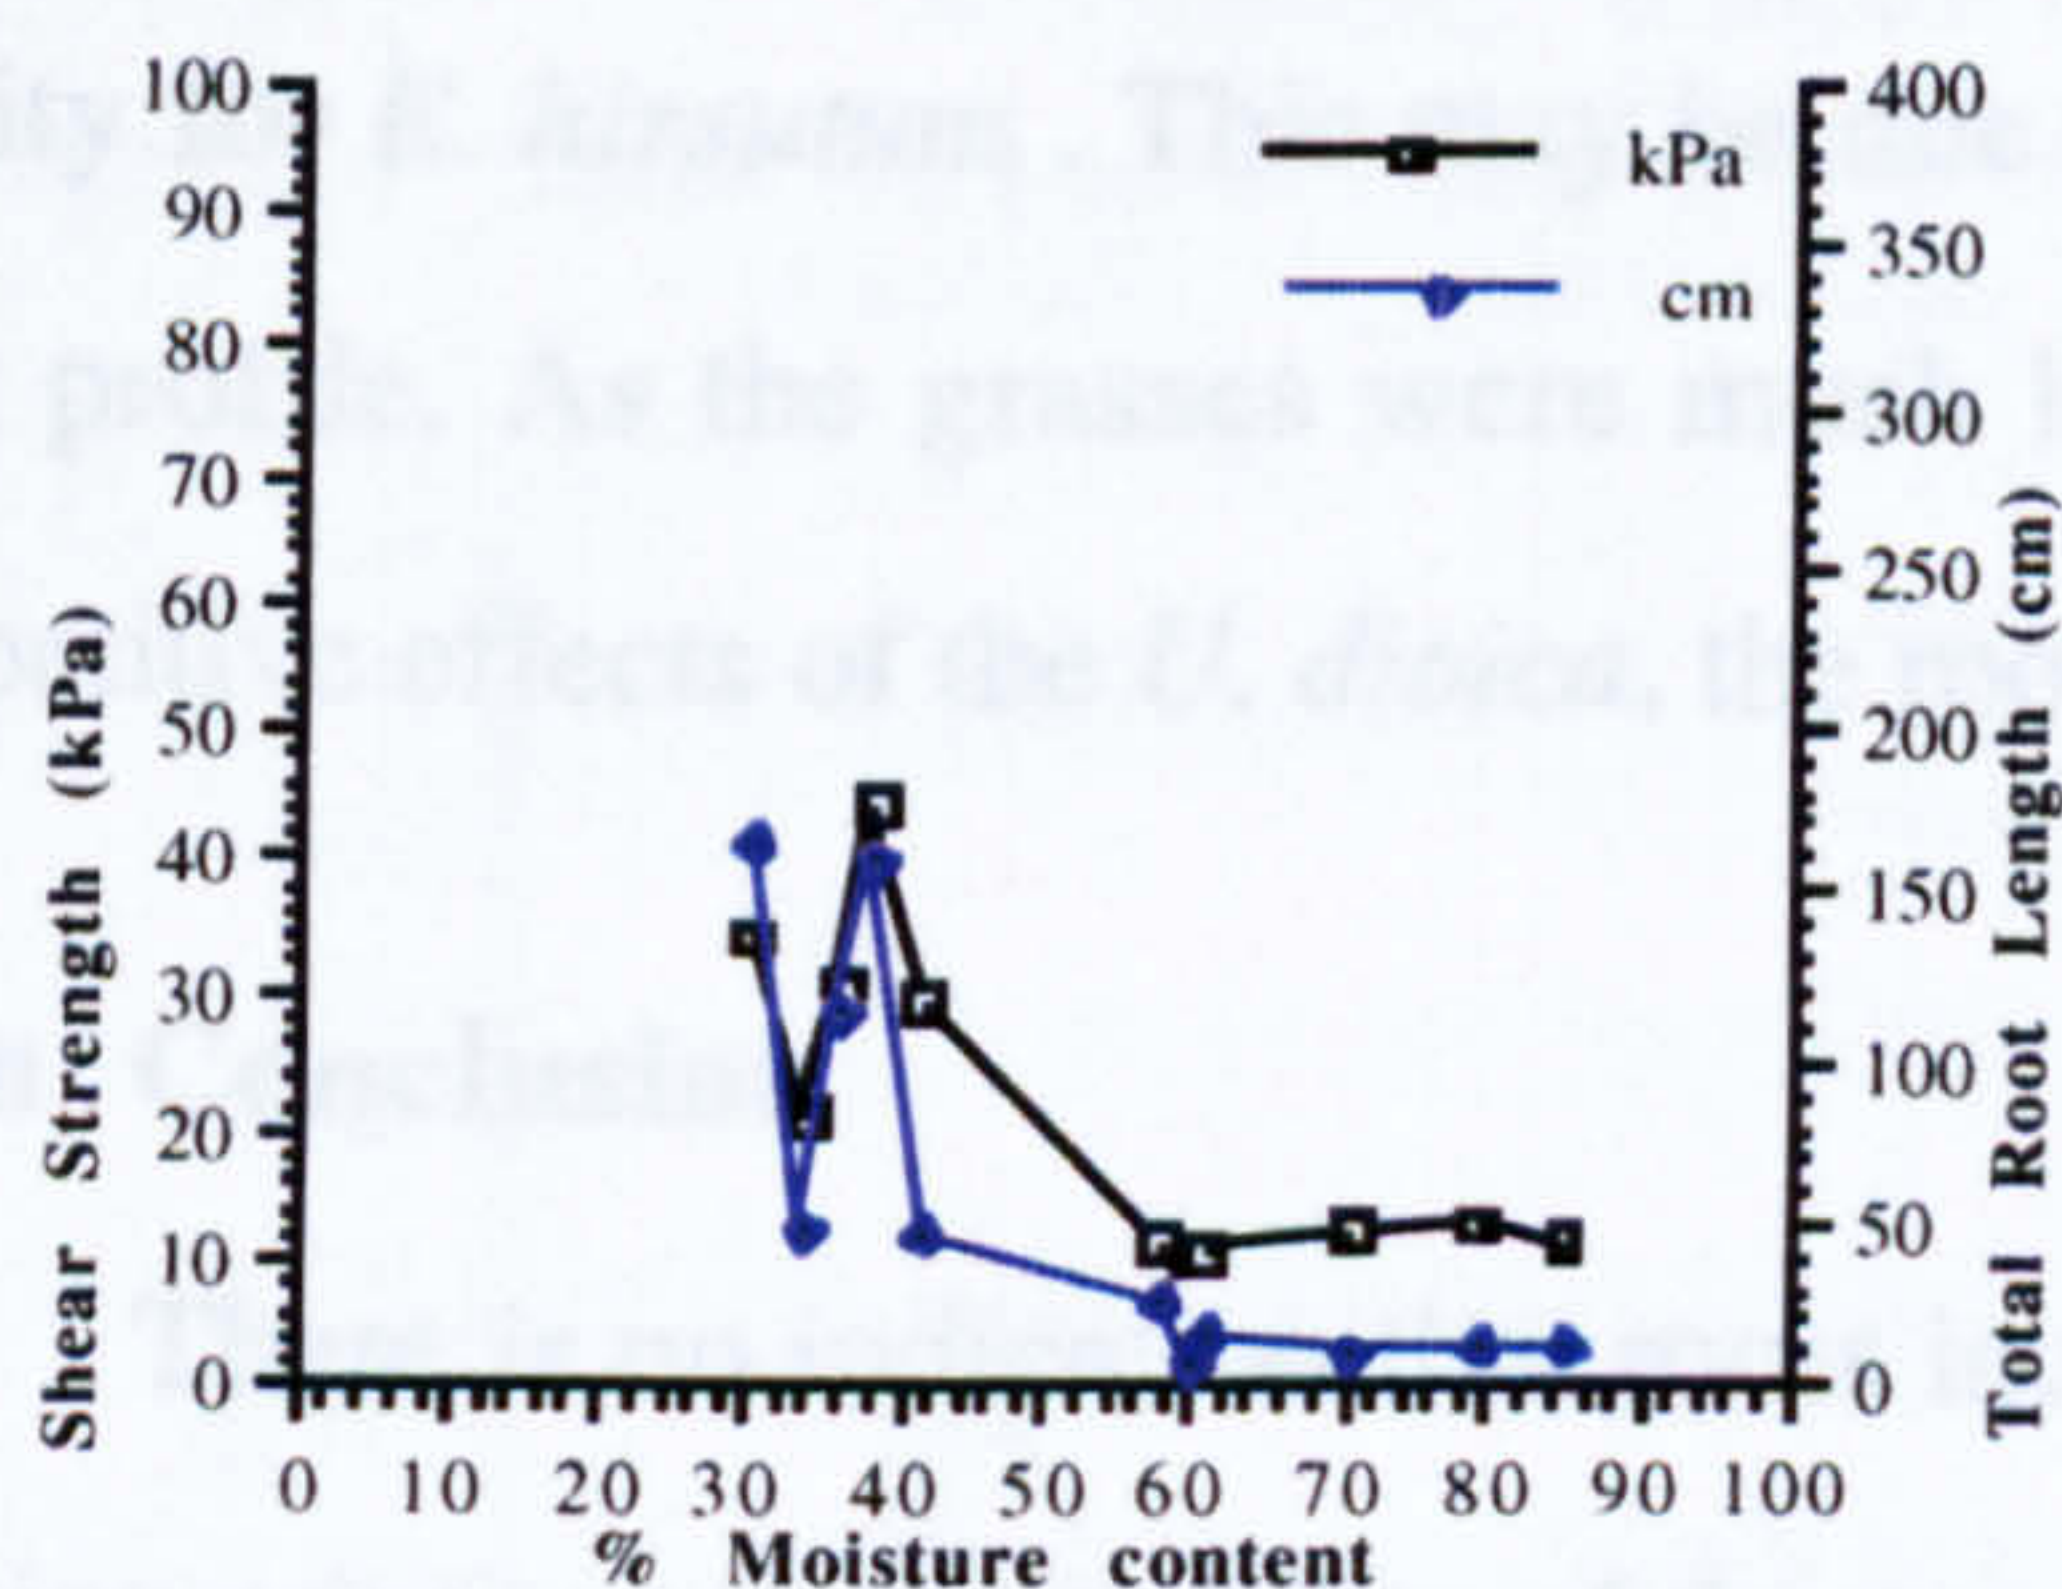
Fig. 3.14c : Shear strength, Root length and Moisture content variations (May 1981)
Naturally vegetated banks dominated by *U. dioica* at levels 2 to 4;
